MULTICHIP CERAMIC PACKAGE 28

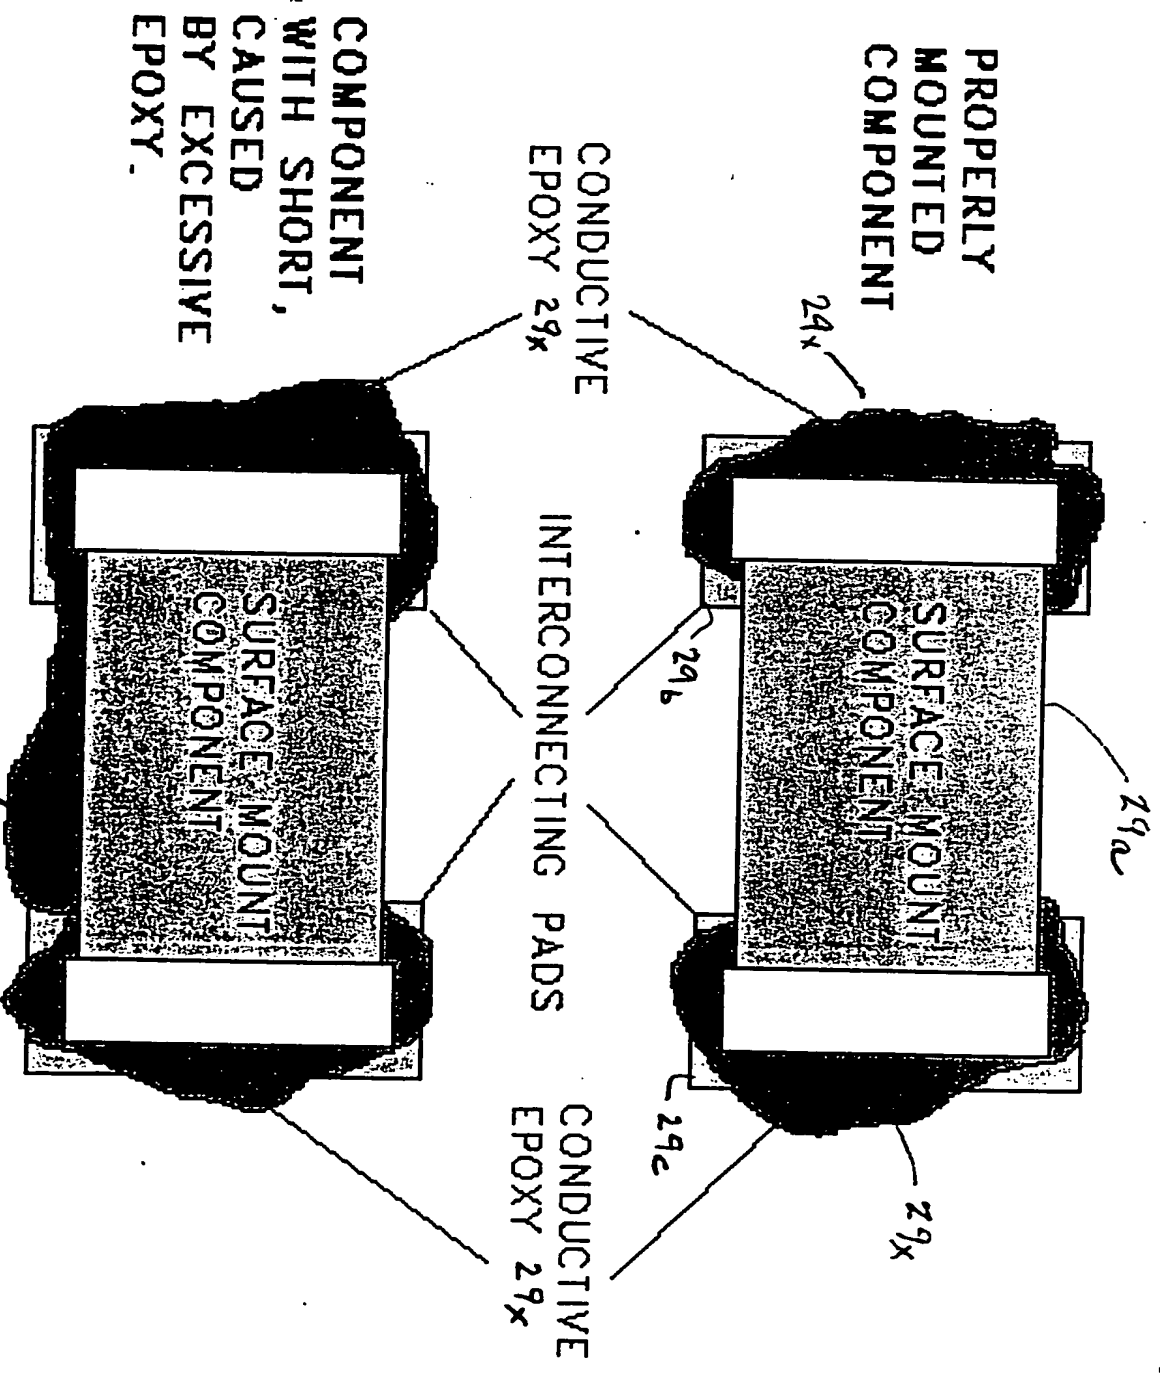
FIG. 2A

COMPONENT WITH SHORT, CAUSED BY EXCESSIVE EPOXY.
